Manhole Inspection Summary

Manhole # S37YY_042MH

Insp Date: **12/29/06 10:45 AM**

Location Address: **415 BRENTWOOD AVE**

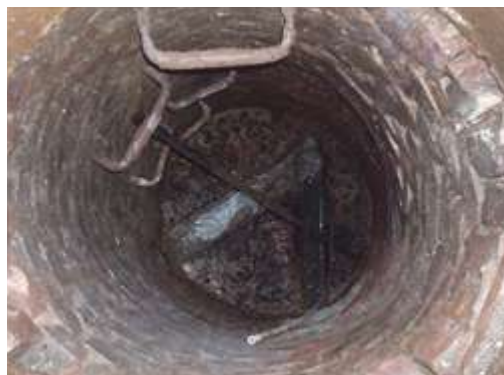
Top View

Corroded steps. Evidence of surcharge - Bench debris.

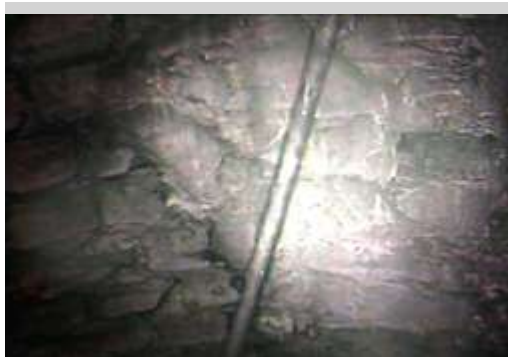
Defect

Barrel deterioration and infiltration.

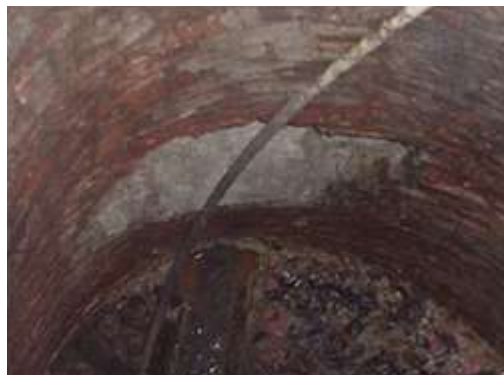
Defect

Comments **HUGE HOLE IN WALL OF BARREL AT 8 OCLOCK POSITION, GREASE IN CHANNEL.**

Barrel deterioration and infiltration (hole).

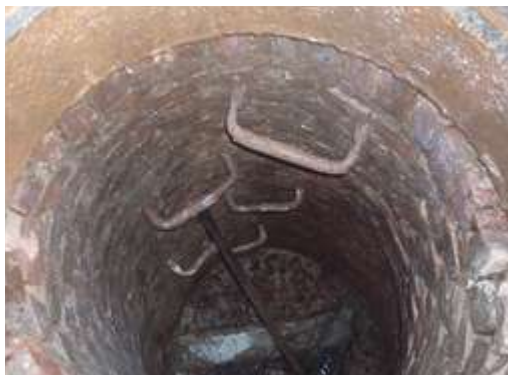
Defect

Frame leaks. Adjustment deterioration and infiltration. Corbel infiltration.

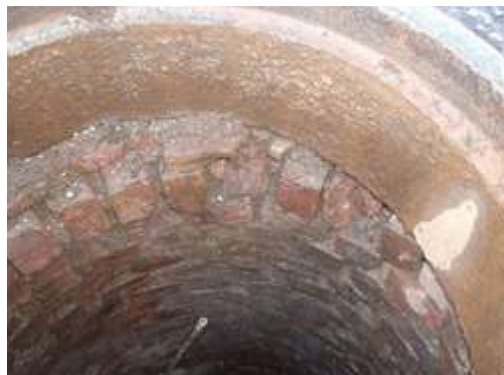
Defect

Frame leaks. Frame offset. Adjustment deterioration and infiltration.

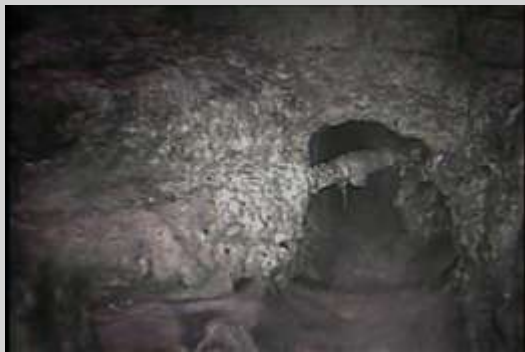
8 in. Circular Gravity Sewer Pipe Out @ 12 O'Clock

Deposits: ☐ None ☐ Mud ☐ Sludge ☐ Debris ☒ **Grease**

Silt Depth: **0** (in.) Deposits Extent: **Medium**

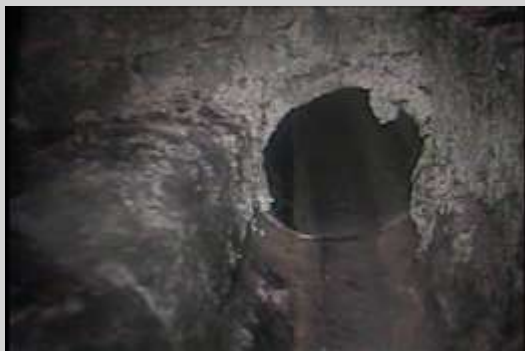
8 in. Circular Gravity Sewer Pipe In @ 6 O'Clock

Deposits: ☐ None ☐ Mud ☐ Sludge ☐ Debris ☒ **Grease**

Silt Depth: **0** (in.) Deposits Extent: **Medium**

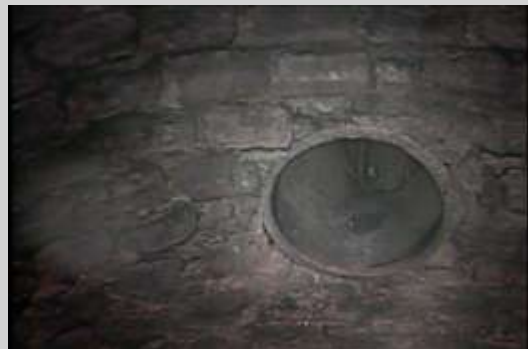
Pipe In @ 8 O'Clock

Deposits: ☐ None ☐ Mud ☐ Sludge ☐ Debris ☒ **Grease**

Deposits Extent: **Medium**

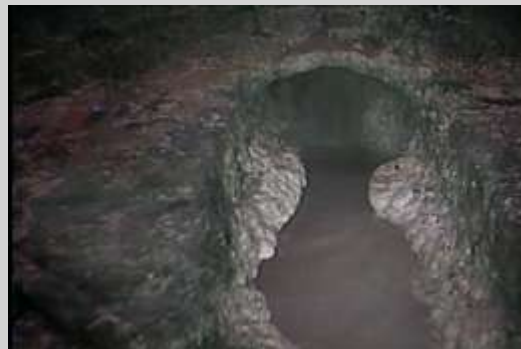
Drop In @ 8 O'Clock

Drop: **Outside** Rod and Bar

Drop Condition: **Open**
